Rowles-Earp-Hand House  
5842 Main Street, Elkridge  
Demolished

## Maryland Inventory of Historic Properties Form

historic Rowles-Earp-Hand House

HO-502, Kilby House  
5842 Main St., Elkridge  
Surveyed by: Kristin Hill  
April 2003

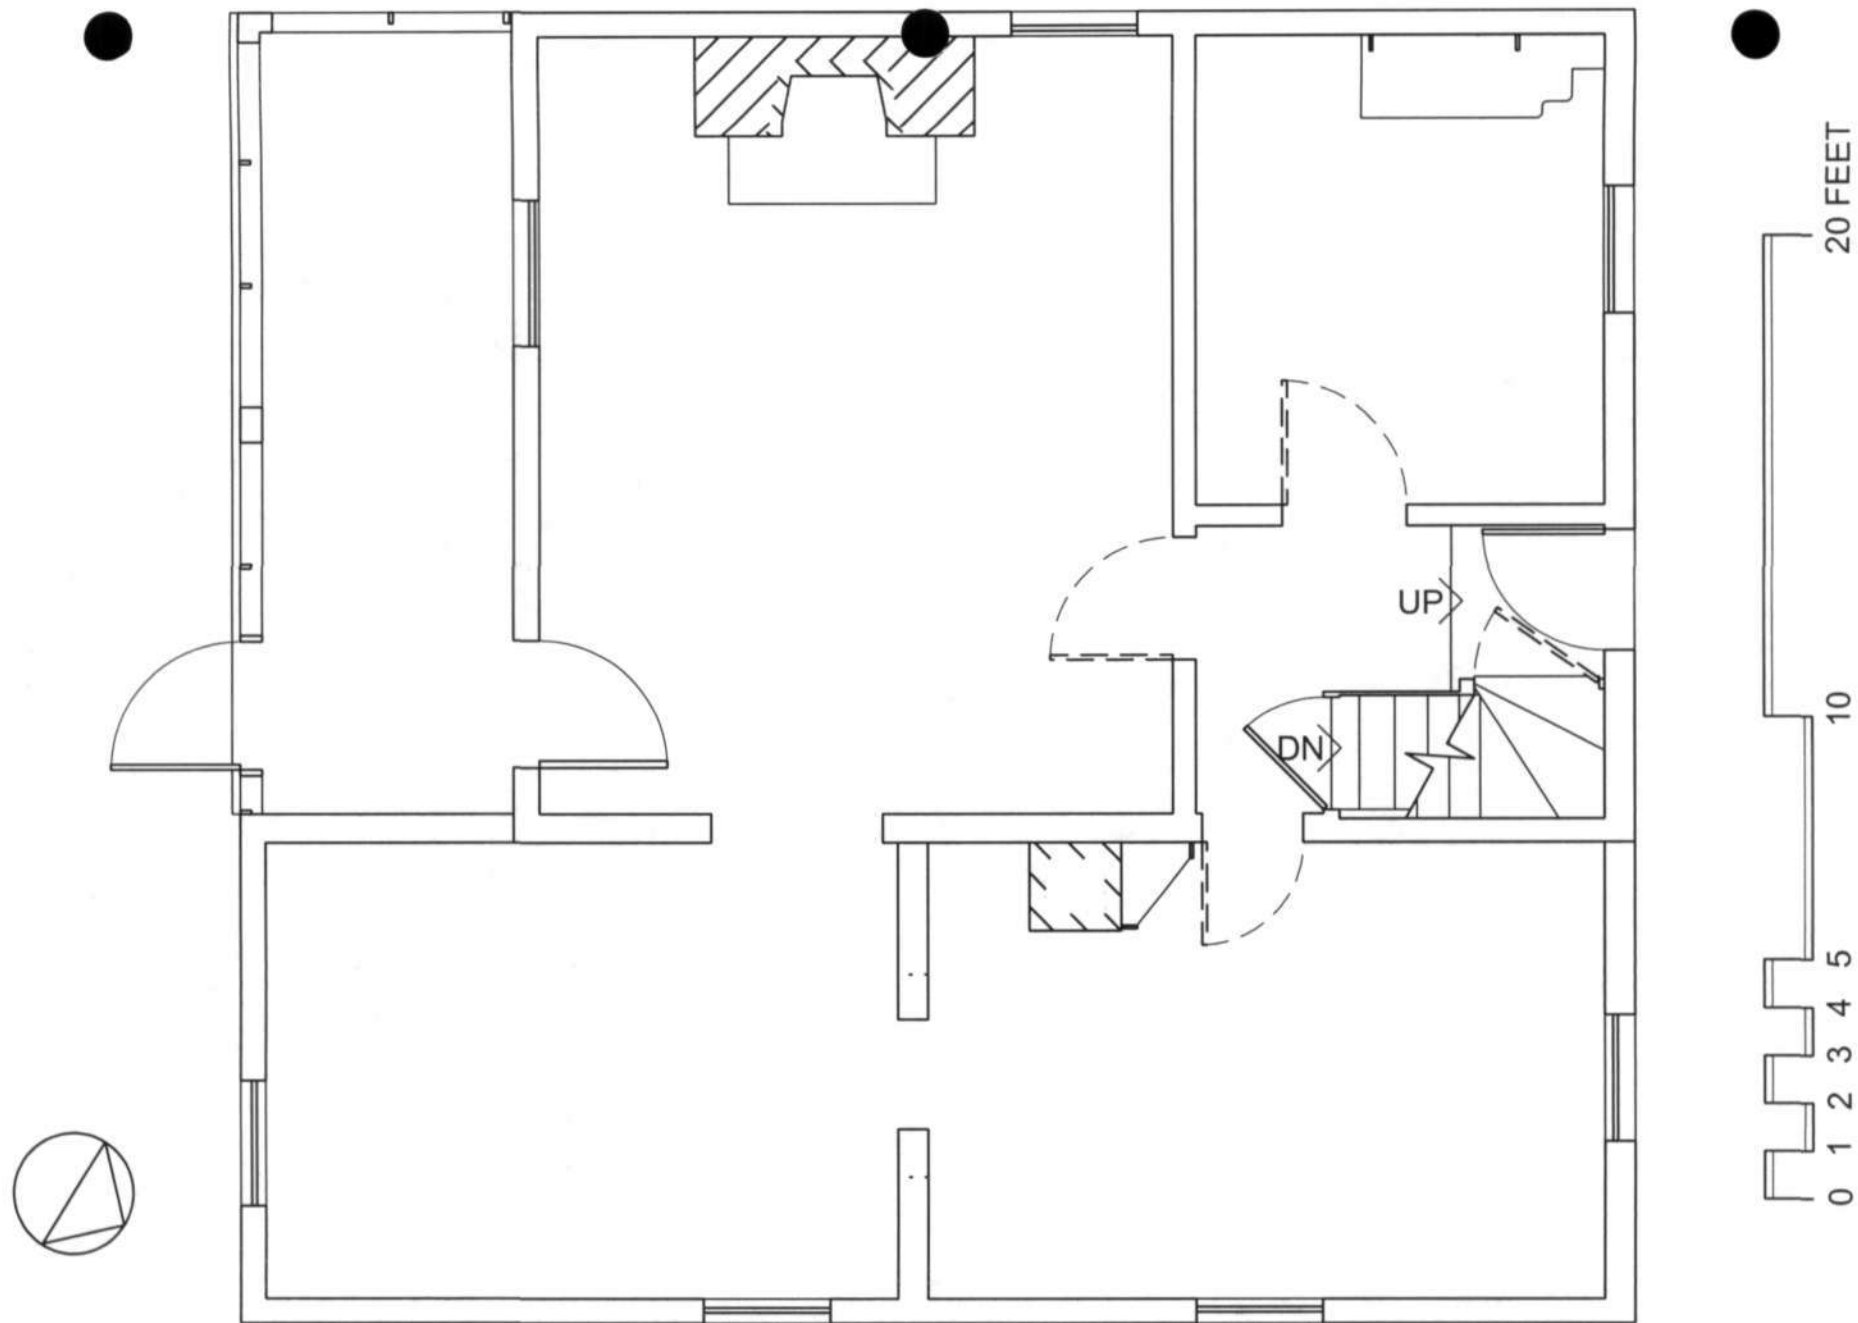
FIRST FLOOR PLAN -- MEASURED & DRAWN BY KEN SHORT -- MARCH 2010

The first story has a hall-parlor plan in the front with three rooms across the back, with the center room being a stair passage. The front door opens into the southwest room. The flooring here is mostly 3¾-inch-wide pine that runs east-west, and several boards at the south end are 6 to 6¼ inches wide. There is textured plaster on the walls and a smooth plaster ceiling with a cast plaster ceiling medallion that consists of alternating bay leaves and four-lobed flowers on stalks around the center. This is an oval medallion with ivy leaf on the ends of it only, and it is all surrounded by three large beads and a fleur-de-lis on all four sides. The west elevation has a fireplace with a new brick hearth, firebox, and surround. There is a wood mantel that has plain pilaster strips with single capitals, a plain frieze, an ovolo bed-mould, and rounded corners to the mantel shelf. The south door and window architrave are plain and are mitered at the corners. The west window has the same architrave, but the sash is mortised and tenoned and pinned at the corners, has ovolo muntins, and has 9-inch by 12-inch lights. The sash has parting beads, but no sash weights or latches. There is plain baseboard. On the north elevation is a doorway to the stair passage, but the door is missing. The door had a rim lock. The architrave here is mitered and has a beaded interior edge. On the east elevation is a doorway with a three-centered arch and no trim.

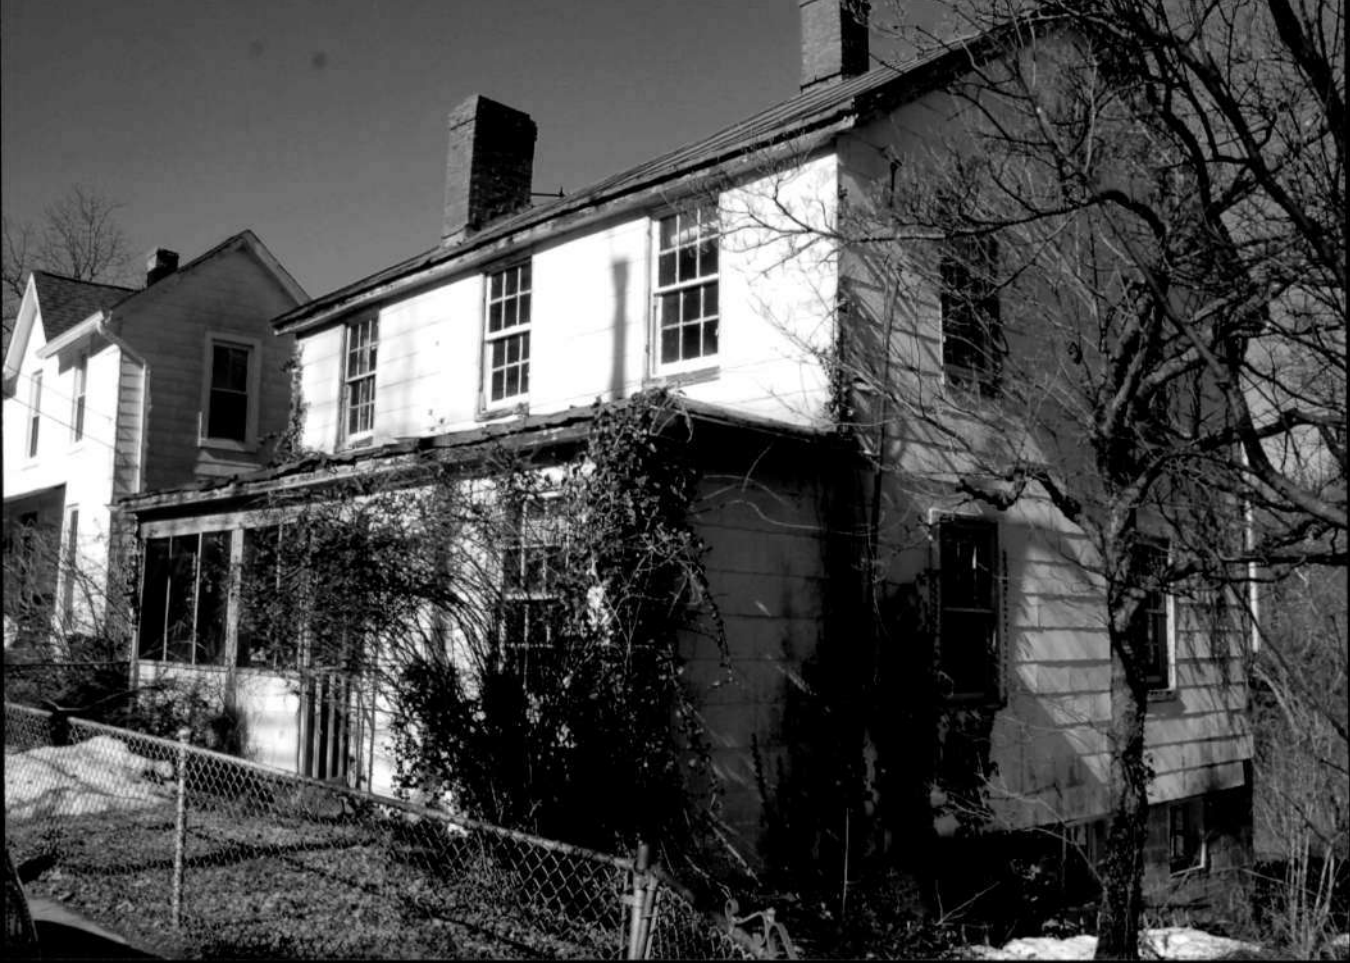
1 of 6

On the south elevation the first story has a central door with six lights over two tall panels. It is hung on butt hinges with pins and has a brass mortise lock. It has head-cut trim. The west bay has a large four-over-four double-hung sash with a wide center vertical muntin. The sash is mortised and tenoned and pinned and opens onto the porch. The window frame has a small bead on the inner edge, and the rest of it is covered. The east bay has an enclosed porch, with the original south wall of the east addition removed to enlarge the southeast room. There is a six-over-six double-hung sash in the enclosed porch. There is a two-bay, one-story porch across the west and center bays of the front. It has boxed posts with asbestos on the balustrade and screened openings. It has a shed roof with standing-seam metal. The second story has three six-over-six double-hung sash in frames that have a bead on the inner edge. There is a wood box cornice.

South and east elevations

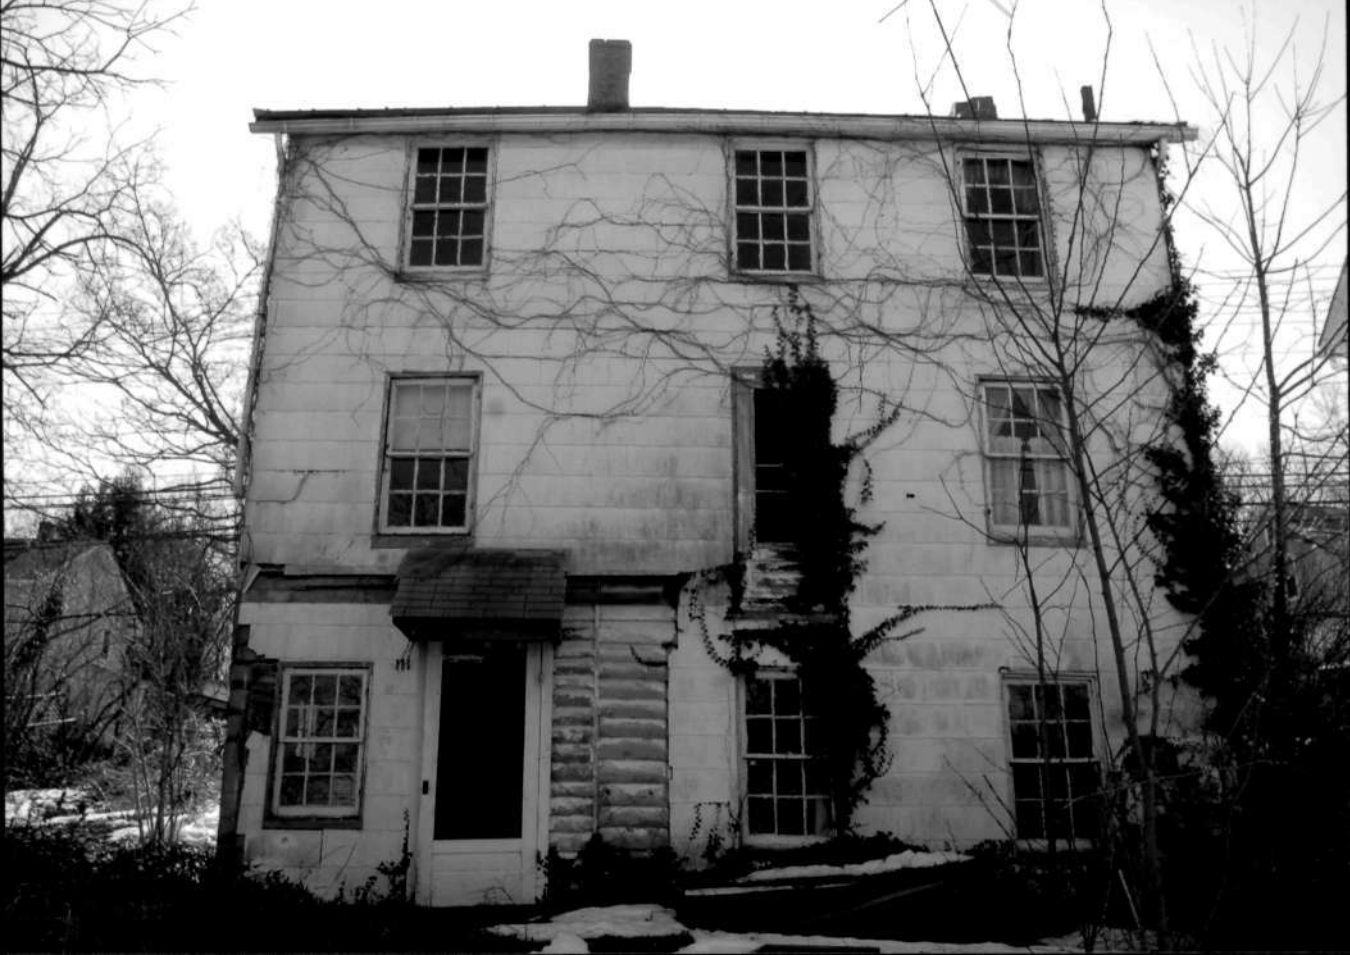
2 of 6

The north elevation foundation, in the east bay, has a six-over-six sash to the east with a beaded-interior-edge frame, and a door next to it that has six panels, with the frieze panels in the center. The panels have sunken fields and quirked Greek ogee panel moulds. The door has a beaded-interior-edge frame and head-cut trim on top of the asbestos shingles. There is a new hood over the doorway. There is a corner board between the east and center bays and both sides have siding fastened with cut nails. The center and west bays have a six-over-six sash in a beaded-interior-edge frame, and the walls are covered with asbestos shingles. On the first story there is a door in the center bay that is not visible for inspection. There is a typical six-over-six sash to each side. The second story has three typical six-over-six sash. The west bay is closer to the center than is the east bay.

North elevation

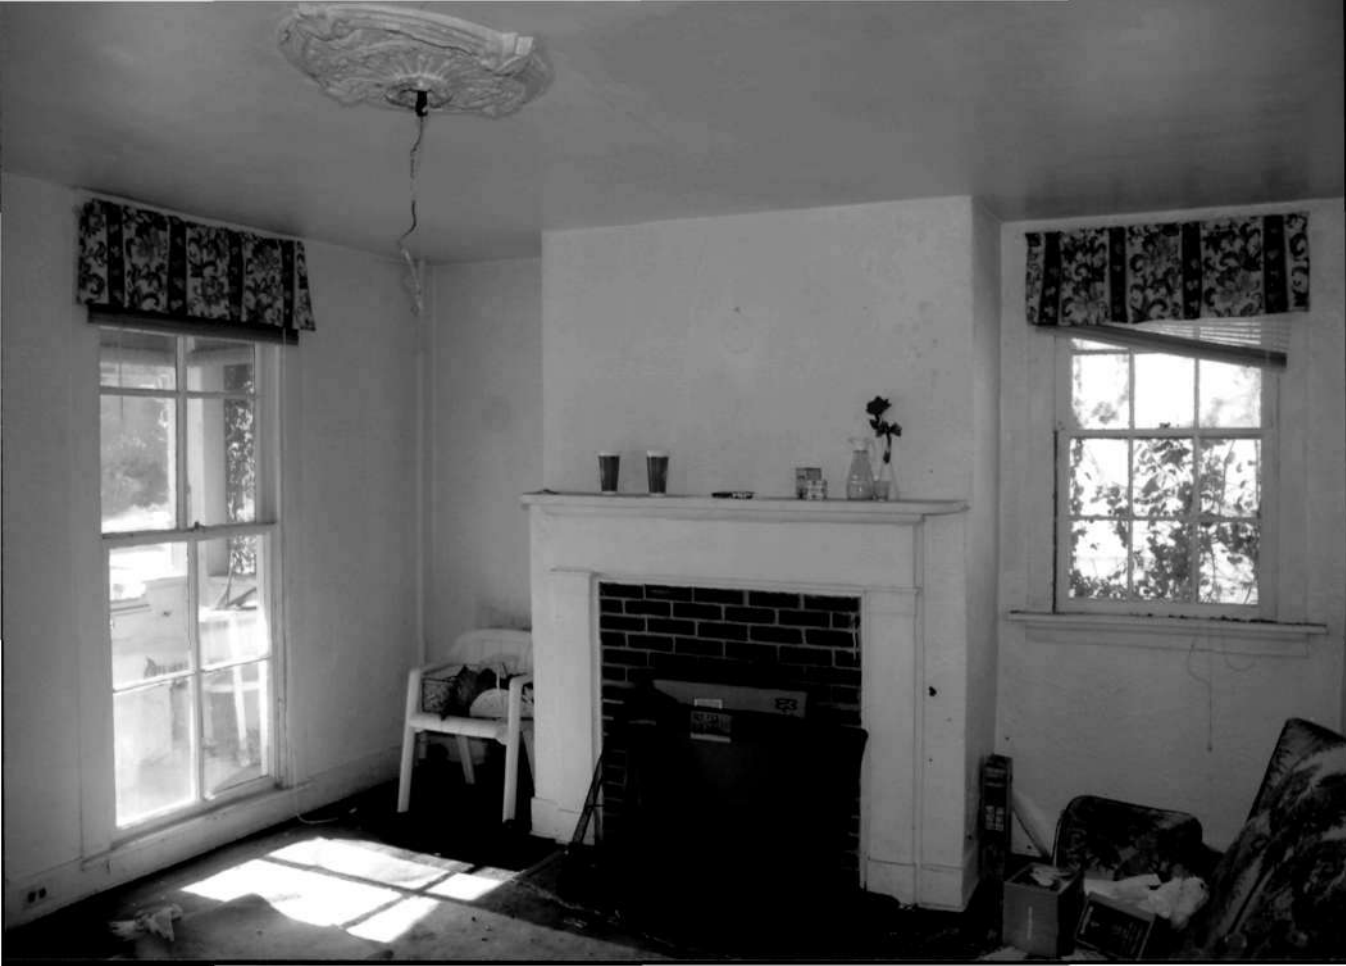
3 of 6

In the first story southwest room, the northwest corner of the wall was opened up for examination of the construction of the building. The wall had plaster on circular-sawn lath that was fastened with cut nails, with a skim coat of textured plaster over top of the earlier plaster. There is a guttered corner post on the northwest corner that has a sawn face on the south side and a sash-sawn face on the east side. The south face is  $3\frac{3}{4}$  inches deep and the east face is 4 inches deep, with the gutter being  $1\frac{1}{2}$  to  $1\frac{3}{4}$  inches deep. The existing lath is the only lath that was ever fastened to the corner post. The north wall studs are sash-sawn, are  $3\frac{3}{4}$  inches wide by 4 inches deep, and there is no evidence of down braces in the northwest corner. There is a 1-inch by 4-inch ledger board nailed to the studs that supports the joists of both the southwest and northwest chambers. The studs are spaced 24 inches on center. The joists run north-south, are  $2\frac{1}{2}$  inches by 8 inches, are circular-sawn, and are spaced 15 to 16 inches on centers. They have cross-bracing that is fastened with cut nails. The flooring above is circular-sawn.

Southwest room, vw. southwest

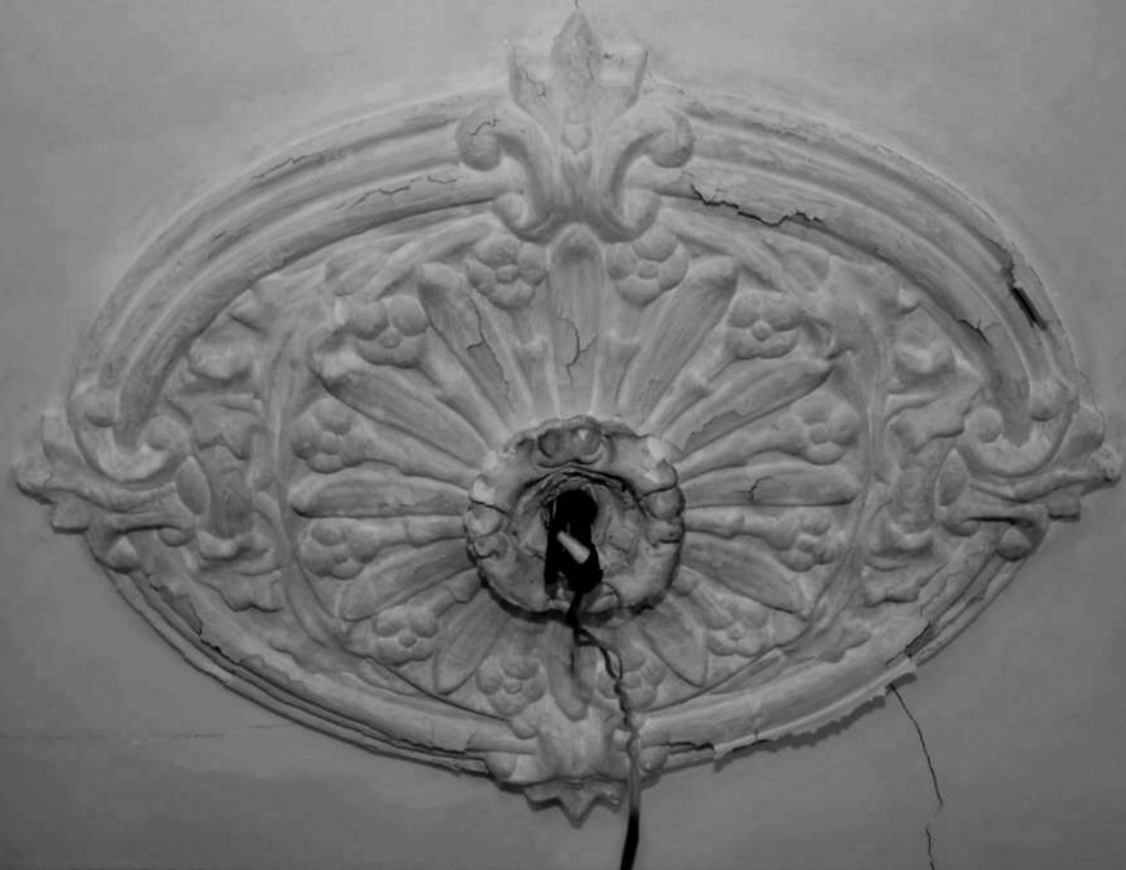
4 of 6

have been used as a kitchen, to get that space up out of the basement. Hands probably also added the plaster ceiling medallion in the parlor at this time, to make that space a little more grand.<sup>2</sup>

Southwest room, ceiling medallion

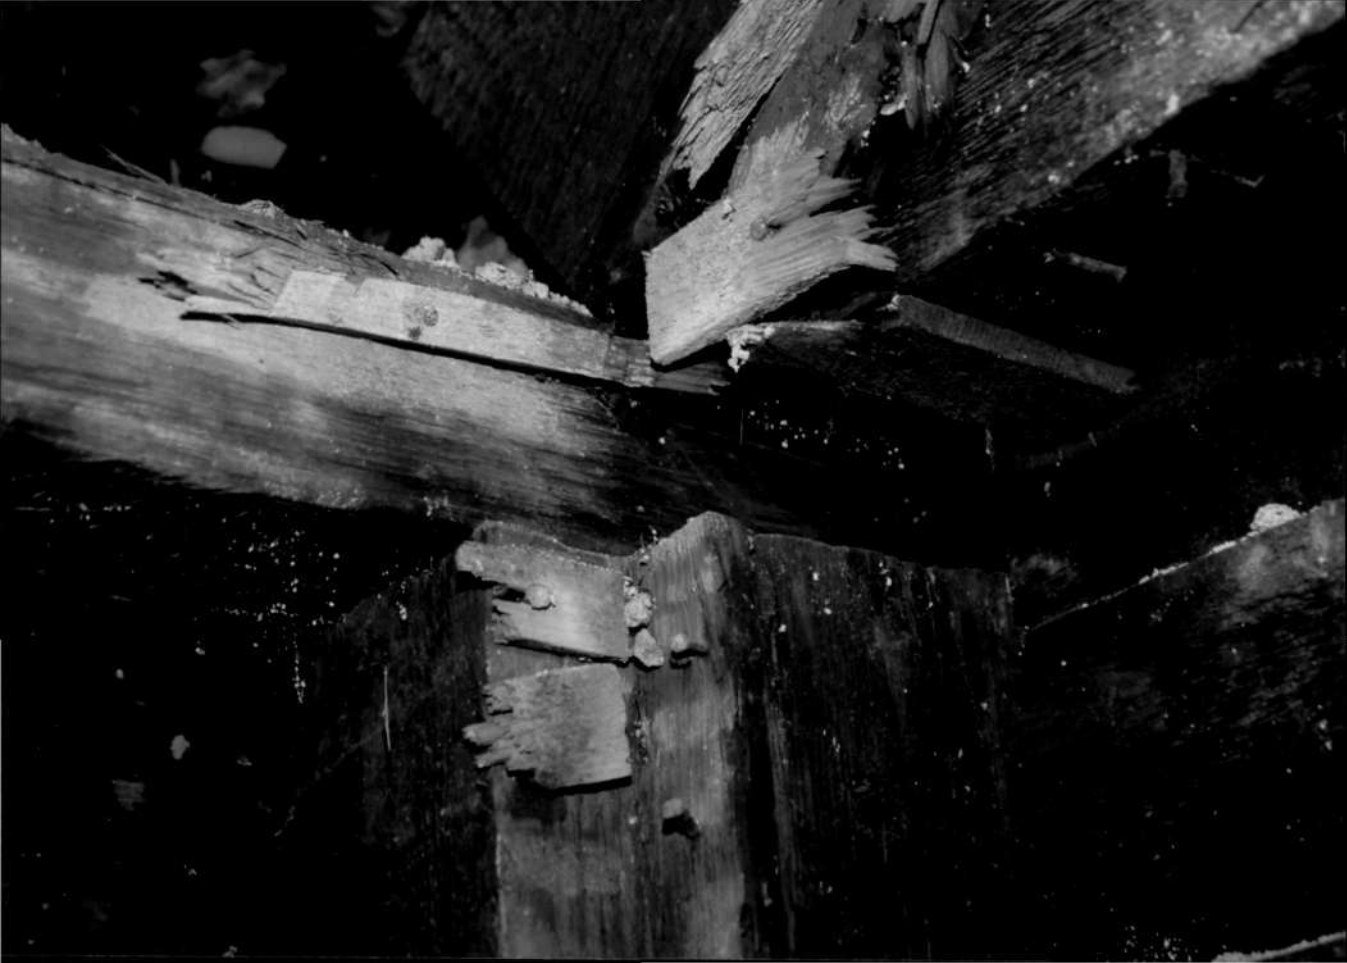
5 of 6

In the southwest chamber the southwest corner of the house was opened up to examine the construction here. It also had circular-sawn lath with cut nails, and this was the only lath ever installed here. There is a piece of riven lath nailed to the front plate, and this was probably intended to get better adhesion for the plaster because there was no possibility of any keying. The plaster has several coats of whitewash, then a thick pink paint or pigmented wash, then a medium-green paint and an olive green paint on top. All of the timber in the wall that was exposed was sash-sawn. The corner post is guttered and is roughly 4 inches deep on each face with a 1½-inch deep gutter. The north face of the corner post is rough and it is not clear whether it is hewn, but it could be deteriorated and appears to be re-used; there is a square hole in the post that is probably from its earlier use. There is another square hole on the north face of this corner post that is 18 inches on center below the top hole. Both holes are 4¾ inches deep and are close to passing through the timber. There is a third hole that is 7 inches below the second hole and 18 inches above a fourth hole; this is another square hole, and all four holes are in a line. There is a fifth hole below all of them that has a broken-off spike in it. The outer 1 inch of the post sits high, and this appears to be a re-used wood stringer from the railroad. This face of the post is blackened almost like soot, and this discoloration is found nowhere else on the post. The post also has some spots of what appears to be a thin layer of clay on the north face. There is no evidence of up braces of the south or west walls. The front plate is 3 inches high and 4 inches deep. The west end girt is 3 inches deep and is 4¼ inches high. The corner post is tenoned into the plate and is pegged to it. There is a nailer on the side of the rafter that conceals the connection of the girt, but the bottom face of the girt is bent to lap over top of the plate. The roof has wide board lath with very smooth wood shingles that have no saw marks. The studs have a center tenon that passes into a mortise on the bottom face of the plate. The weather boards fastened to the outer face of the studs are random-width.

guttered cornerpost/plate/girt  
connection in southwest corner

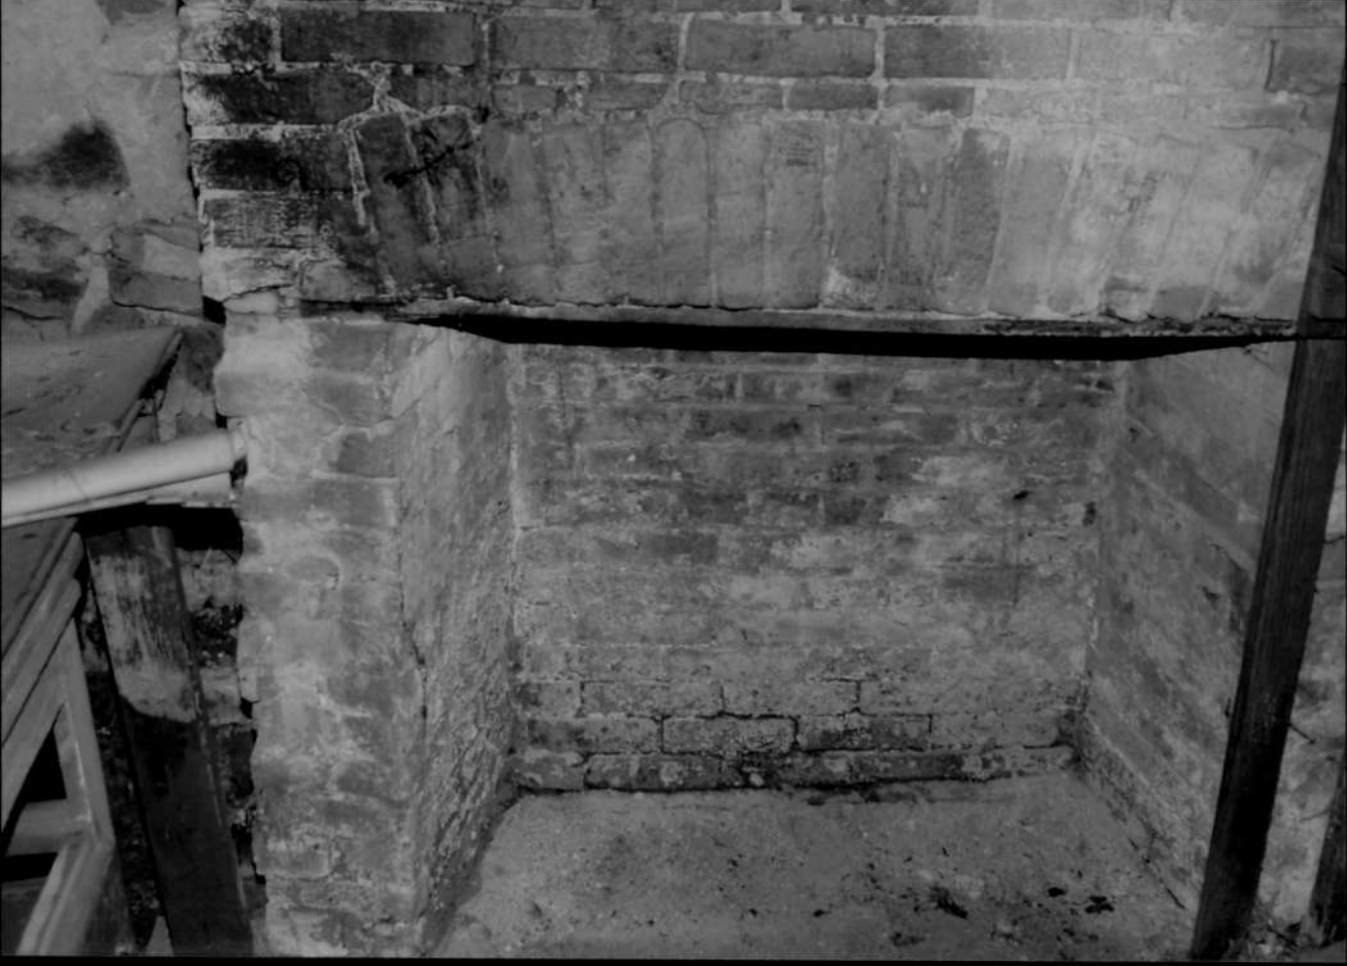
6 of 6

The southwest cellar room has a rubble stone foundation, plaster on the walls, especially on the east wall where there is red paint surviving, and a board ceiling of mostly plain boards that run east-west. There is some bead-board on the ceiling at the north end. The east wall steps back several inches about 30 inches above the floor, with boards sitting on top of this step-back, and circular-sawn lath with cut nails and plaster. The east wall also has a window opening and narrow architrave with a small bead on the inner edge; the architrave is mitered at the corners. The west wall has a fireplace of brick with splayed jambs and a brick jack arch with an iron lintel; there is no crane. The joists above are sash-sawn, run

Basement fireplace

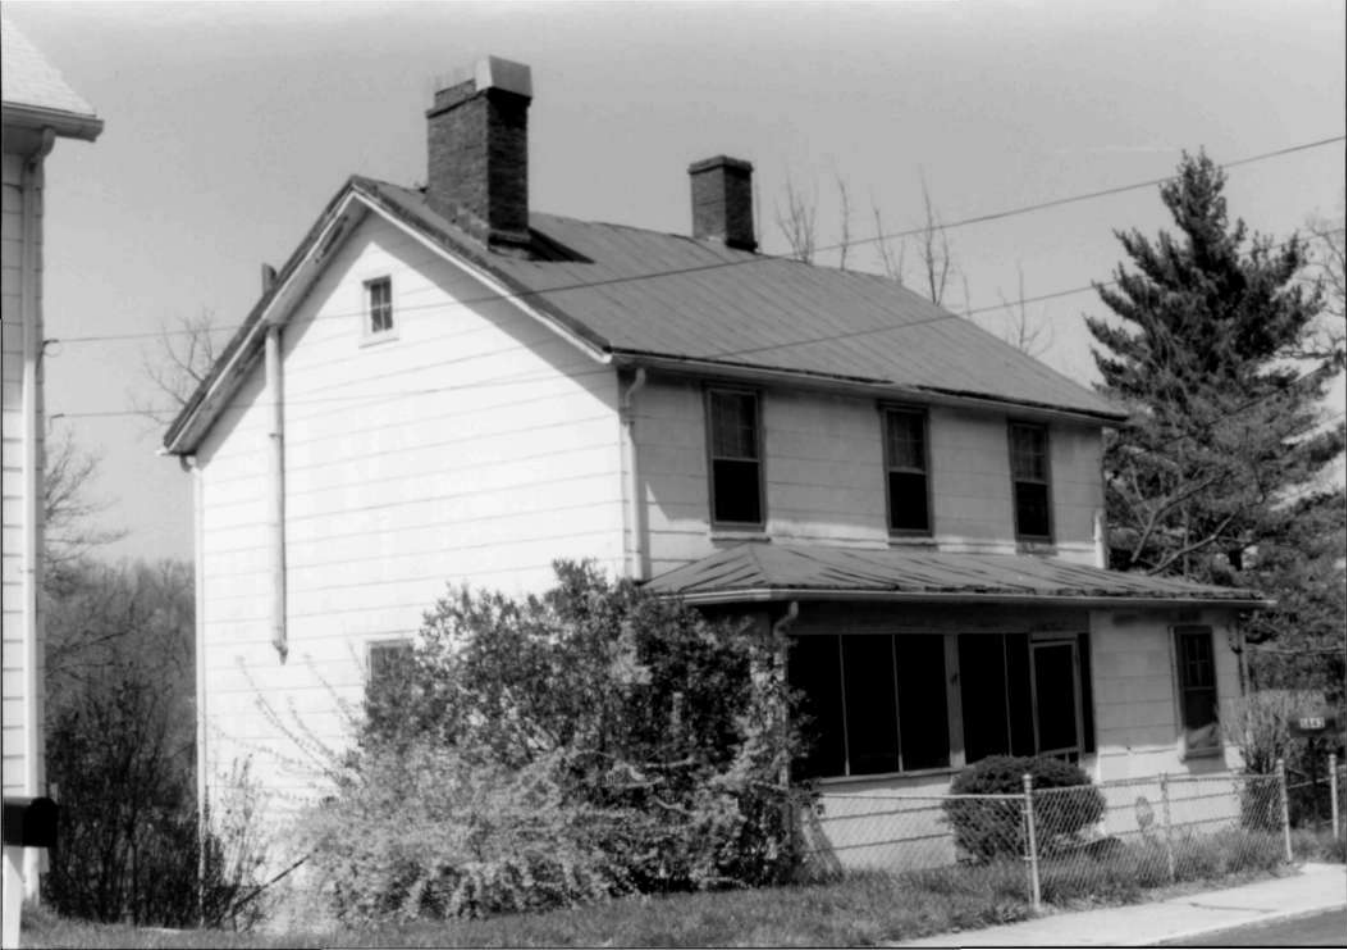
1 of 1

This interesting two story frame dwelling faces south on the north side of Main Street. Recorded in the 1970's as the Kilby House, very little has changed on the exterior of the building though the condition has deteriorated. The two story, three bay, double pile frame dwelling has a side gabled roof pierced by a large interior brick end chimney on the west end of the building on the front slope of the roof. Another smaller, square brick stovepipe chimney is located at the ridge of the roof towards the eastern end of the building. The construction materials of the foundation seem to indicate several additions to the original building. On the west façade, the front half (a single pile deep) has a stone foundation while the back half is brick, but on the east façade, the front half of the house has a brick foundation while the back half is cinderblock. It is possible that the original building was only two bays wide and one room deep and then an additional bay was added to the eastern end of the building and an addition was also made across the back of the building making it two rooms deep. This would account for the variety of foundation materials and possibly the location of the large brick chimney (whose size and form seem much earlier than the smaller stovepipe chimney in the east end of the house) on the front slope of the roof in the original section of the building. The entire exterior of the house is clad in asbestos siding, and the roof of both the house and single story front porch is standing seam metal. Original 6/6 windows are still in place as is the original exterior beaded window trim.

Southwest elevation

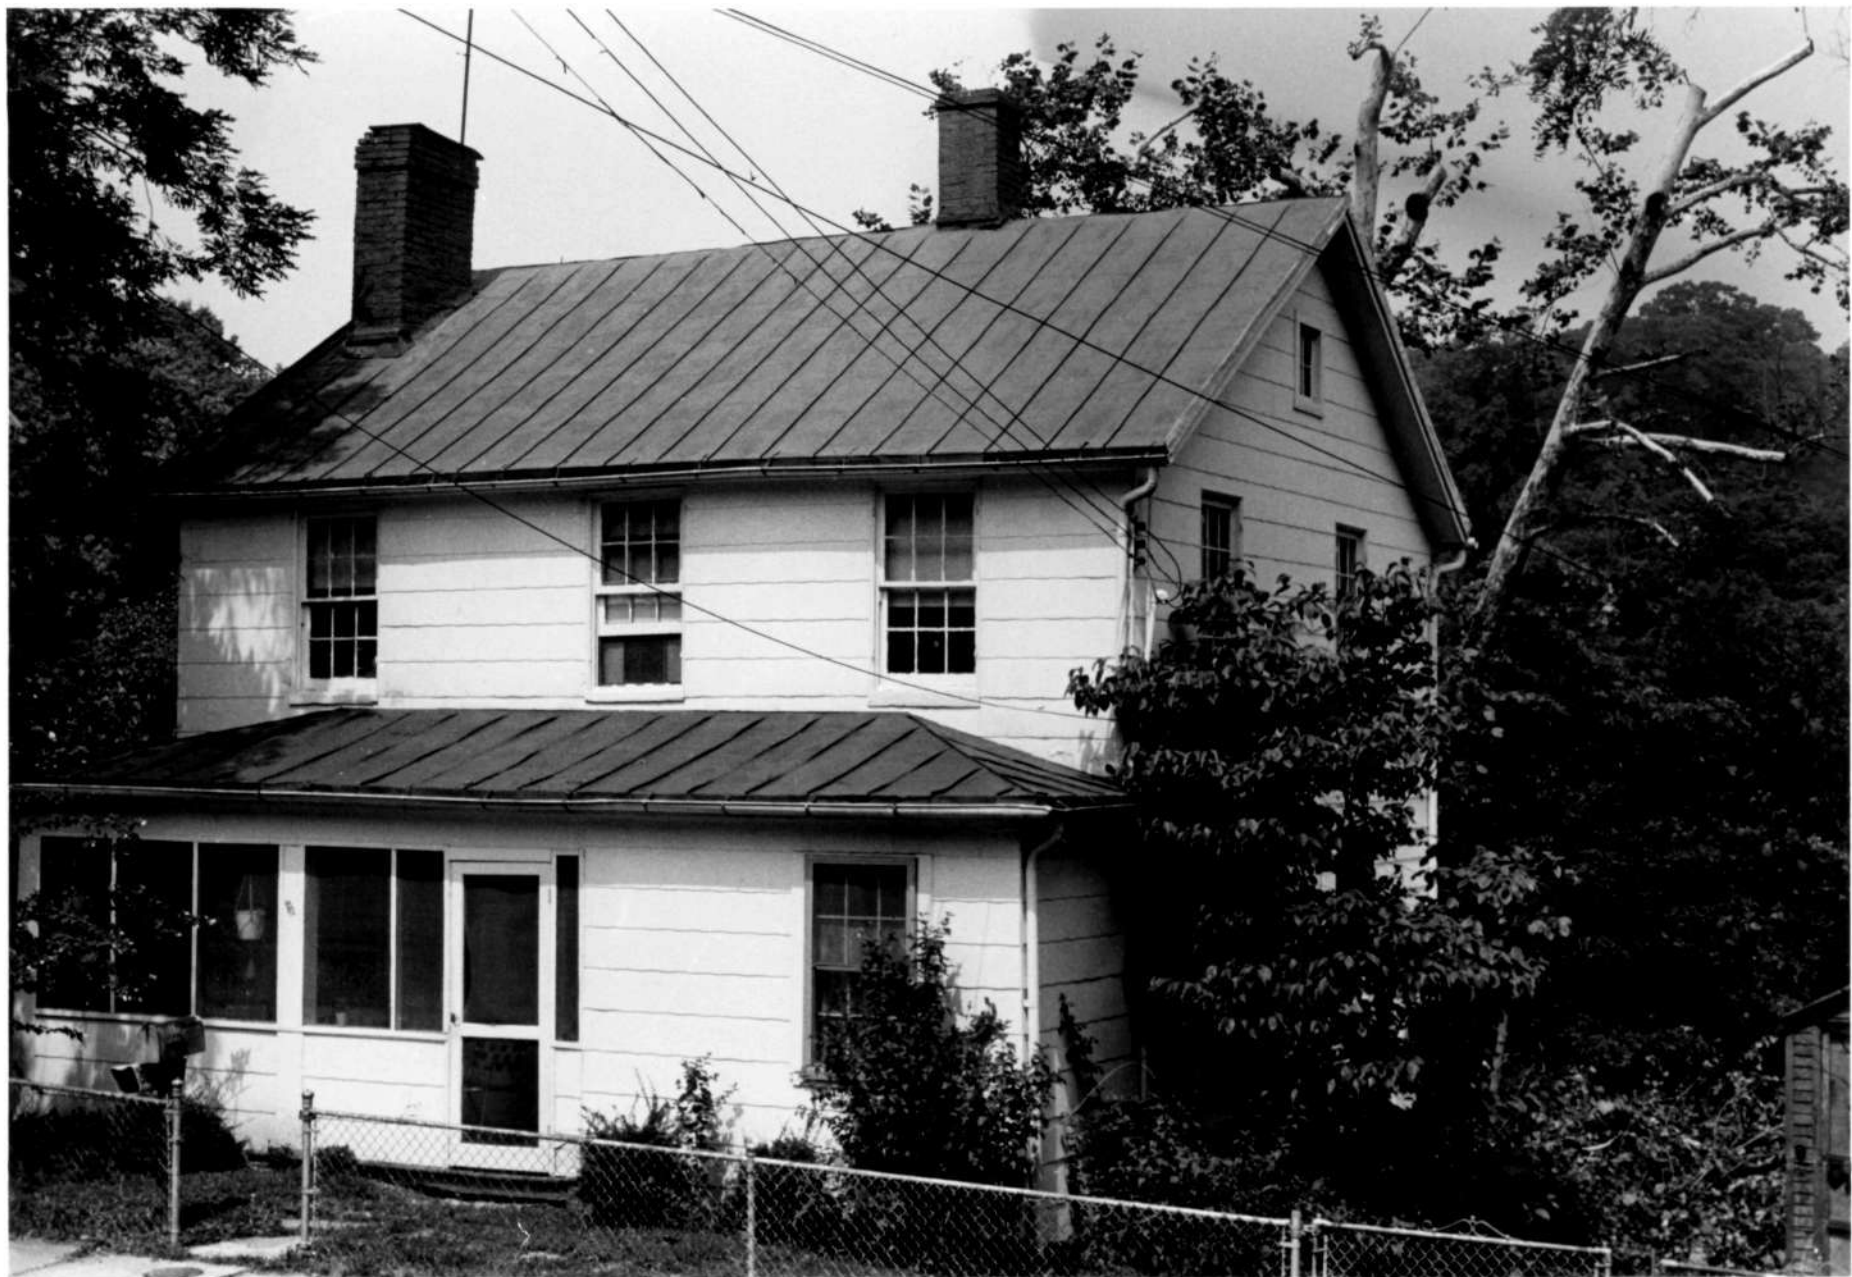
H0.502  
The RILBY HOUSE  
SOUTHEAST

The J. B. Kilby House faces south on the north side of Main Street, Elkridge, just west of Elkridge Springs, HO-501. It is a three bay wide, two bay deep, two story high, gabled roof (running east-west) frame building, resting on a stone and brick foundation with wide brick chimney inset into its west wall and a square brick chimney rising from the center of the east side of its roof.
